## BUILDINGS OF HISTORICAL & ARCHITECTURAL INTEREST SADDLEWORTH LOCAL LIST RECORD

| List No. | <b>1-001</b> |
| Property Name & Address | <b>ARLINGTON HOUSE<br/>Standedge Road</b> |

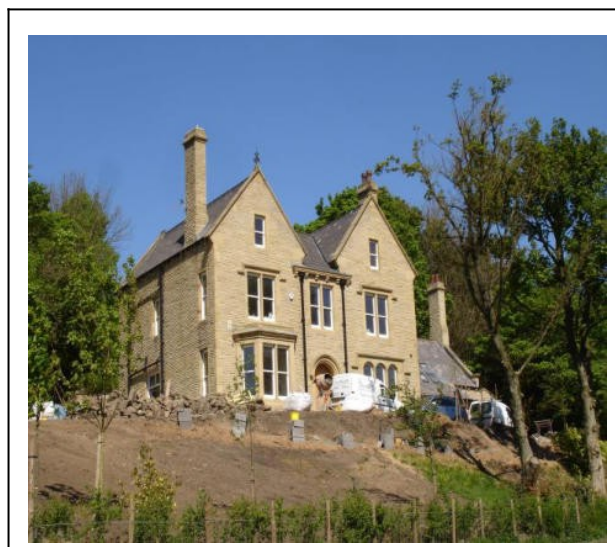
| Photo | 2020 |

Built before 1889 by Jonathan Chambley, woollen manufacturer, proprietor of Stonebottom Mill, Dobcross. 2 storey with attic, 3 bays, double depth, hammer dressed sandstone with quoins and protruding lower courses. Blue slate roof, 3 water tabled tall stone gable stacks. Front elevation, coped gables right and left with kneelers, ground floor left, 4 sash window bays, squared stone surrounds, chamfered sills and jambs with pointed mullion in centre frame, decorative cornice with leaded flat top, to right 3 arched window with chamfered dressed stone surround and drip hood. 1st floor left and right 3 sash windows with dressed stone surrounds and drip hood. Dressed stone surround attic windows in gables. Centre bay with pitched roof, ogee corbel brackets, central arched doorway with decorative mouldings and arched stonework, door set back. Left elevation with corbels, one ground floor and 2 1st floor sash windows, chamfered dressed stone surround with ground floor larger 21C replacement. Right elevation ground and 1st floor sash windows with rear half matching extension much modernised 21st C. Rear lean to, doorway with stain glass window 1st floor. Same style outhouse car/stables built into rear bank. Wrought iron finials on front gable apex. All extensively refurbished including slates 21st C.
