## BUILDINGS OF HISTORICAL & ARCHITECTURAL INTEREST SADDLEWORTH LOCAL LIST RECORD

| List No. | <b>3-022</b> |
| Property Name & Address | <b>Warth Mill, Huddersfield Road</b> |

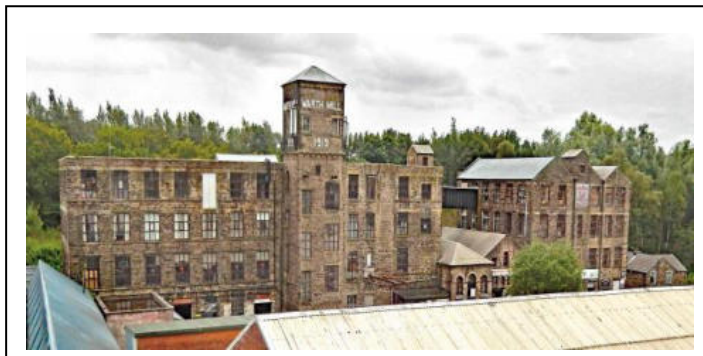
| Photo | 2020 |

LC18 textile mill destroyed by fire in 1915. Rebuilt by CWS manufacturing flannels. Bought in 1928 by Tanner Brothers producing tyre fabric. Front elevation: left bay 4- storey with 4x9-pane windows on three floors with ground floor hidden, sills and lintels continuous string, sills proud rock faced, roof appears flat; 2nd bay left tower block, each floor taller than last block suggesting different build, 5-storey with ground floor with single entrance, 1x9-pane and 1x6-pane offset windows each of 3 floors, tower of ashlar-blocks with string and corbel decoration at 5th floor level with date '1919 and CWS' on each face in what looks like tile material; 3rd block from left is attached to tower block but has straight joint suggesting separate build, 4 floors of 2x9 pane windows of which 1 on ground turned to a door, gable with 4 narrow 'toilet windows per floor, depth of building hidden. 4th block same with 5 floor hoist wheel house and bridge to remaining block at 3rd floor level, in front 2x 2 & 3 storey buildings with stone arched windows of later period. 5th block 4 storey 3 bays each bay with gable, sills in string course; blue slate roof with 2 valleys, 6x9 pane windows per floor bays 1 & 3 with doors on ground floor, hoist wheel house 5th floor centre bay with 1 window 3rd floor and 1 large per floor, the block 5 bays deep. Cast iron downspouts with ground floor inset into wall. Diggle Brook runs under the central concreted concourse. Various states of repair. Warth Mill (fulling) 1786 *SHS Bulletin* Vol 13, No. 2.
