## BUILDINGS OF HISTORICAL & ARCHITECTURAL INTEREST SADDLEWORTH LOCAL LIST RECORD

| List No. | <b>4-003</b> |
| Property Name & Address | <b>Former Diggle Industrial Co-operative Society Ltd.</b> |

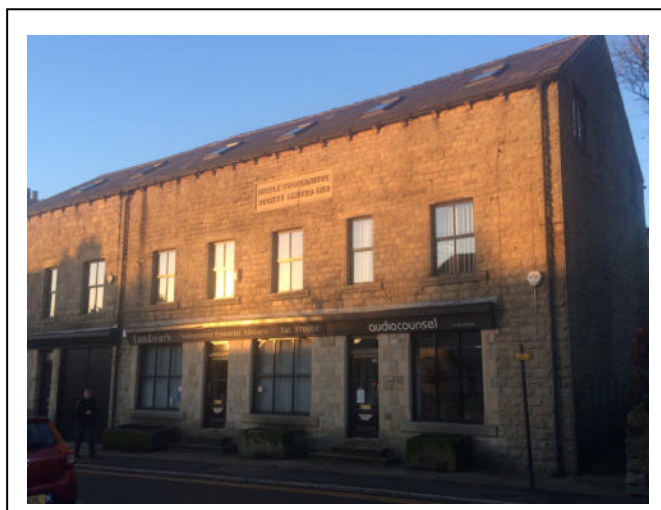
Built 1868. 3-storey building built in 2 stages original to right of drainpipe with later garage, butchers and office door added to left. 3-storey shop with blue slate roof. 2x stone stack chimneys with dressed stone trim at gable end and ridge (gable end before extension built). Walls of coursed Millstone-grit with sandstone trim. Ground-floor 3-bays. 3-shop windows separated by 2 doors. Ashlar stone-surround to doors and windows with sills chamfered and proud. First floor – original 5-equally spaced windows (one narrower) with chamfered lintels and chamfered and proud 2-layer sills. Additional 3 windows when extended. 3-storey watershot right gable end with 2 windows, symmetrically placed at first floor level. Door at ground level towards rear of gable end. Original cast iron gutter supported by ogee stone corbels. At rear separate 2-storey millstone grit building joined at some later date to main building by lean to/cat slide roof. This section itself has a later single storey addition Both have original barred windows. All windows, doors and Ashlar surrounds replaced in late C20 when building was renovated for commercial use. Good repair.

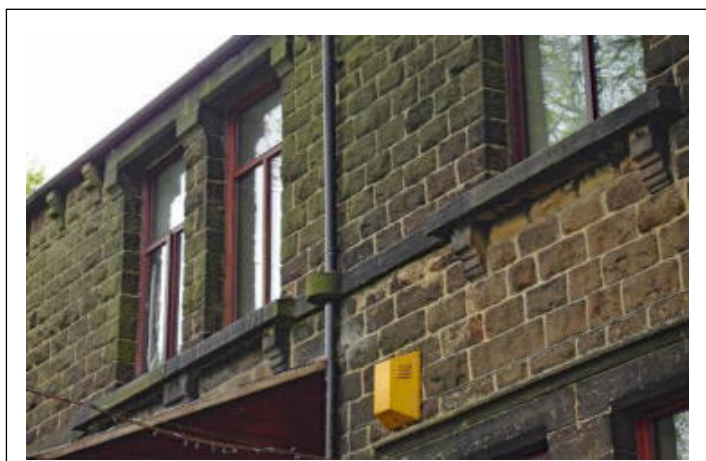
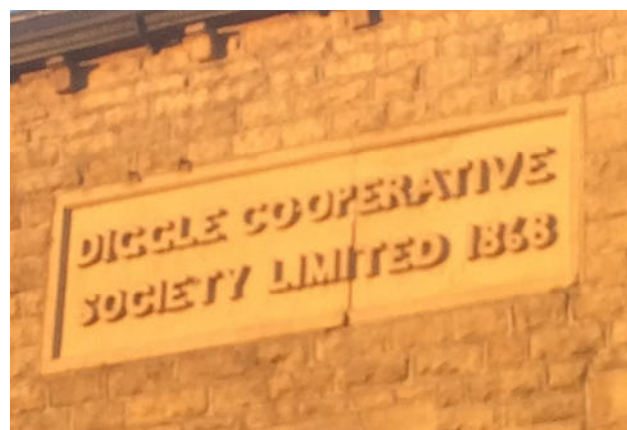
Sandstone plaque 'Diggle Cooperative Society Ltd 1868.' String-course with circular stone drainpipe-bracket at rear.
