## BUILDINGS OF HISTORICAL & ARCHITECTURAL INTEREST SADDLEWORTH LOCAL LIST RECORD

| List No. | <b>1-010</b> |
| Property Name & Address | <b>Spring Hill, Spurn Lane</b> |

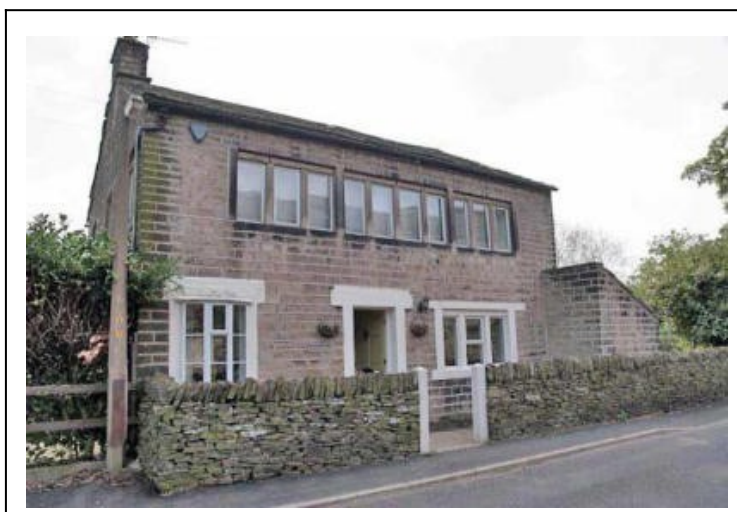
| Photo | 2020 |

Substantial stone weaver's house. Date stone inside 1780, but mapping indicates possibly E C19. 2-storey front, 3-storey rear, 2-bay, doubled depth, watershot stone. Graduated stone slate roof with gable watertabled stone stack. Front elevation: central square faced stone surround doorway with double lintel. To right ground floor 3-light square flat-faced recessed mullion window, to left inserted C20 bow window with double-lintel. 1st floor 1-light recessed square flat-faced mullion window with 2-king mullions. Gable ends 3 & 2 light recessed square flat-faced mullion windows, central one with mullion missing. Right gable with single storey lean-to with graduated stone slate roof, at first floor 3-square flat-faced windows with a suggestion of remaining damaged mullions new window frames & enlarged opening of attic window. Cellar door at ground floor level. Left gable: basement C20 garage door. 2nd floor 2 x 2-light square recessed windows with single mullion & central square window with new wooden frame. Rear elevation hidden but known to have multi lights to each floor. Good order. Has been 2 dwellings mid C20.
