## BUILDINGS OF HISTORICAL & ARCHITECTURAL INTEREST SADDLEWORTH LOCAL LIST RECORD

| List No. | <b>1-012</b> |
| Property Name & Address | <b>1 Spurn Lane</b> |

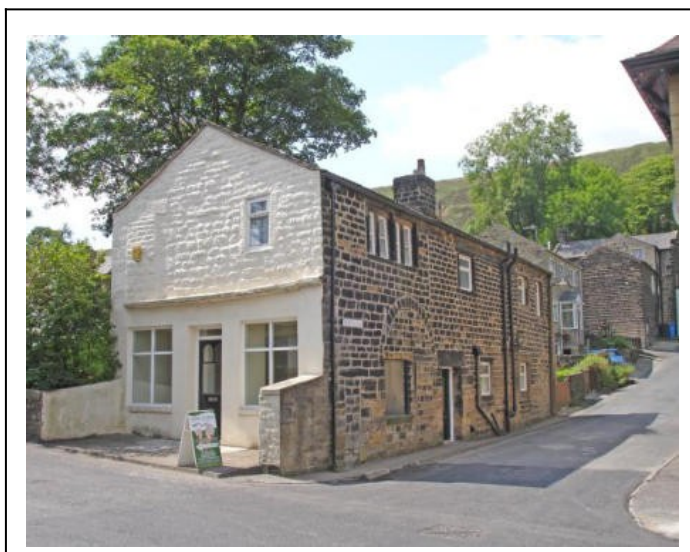
| Photo | 2011 |

Row of buildings used as house, barn and shop (closed). Much reworked E19C 2 storey, 3 bay, single depth. Roof replaced tiles, ridge water tabled stack. Hammer dressed stone centre and right bays, squared rubble left gable and rear end bay. Front elevation (roadside) left bay with in-filled arched barn doorway with insert window, 1st floor 4 light recessed square faced mullion window with 1 king mullion. Visible joint line including part of arch, centre bay dressed stone surround doorway with small inserted window, single window 1st floor, right bay visible joint line, with doorway part in-filled with window, 1st floor 2 inserted windows. Right gable infilled doorway, left gable ground floor centre doorway and 2 large shop windows walls rendered above windows projecting rough stone string course. 1st floor left in-filled taking in door, right rough stone surround single light window. Rear visible joint line between left bay and centre, windows sash side 2 per bay 1 ground I 1st floor with right ground now a French window and left ground blocked. Good condition
