## BUILDINGS OF HISTORICAL & ARCHITECTURAL INTEREST SADDLEWORTH LOCAL LIST RECORD

| List No. | <b>3-001</b> |
| Property Name & Address | <b>Cloughbottom</b> |

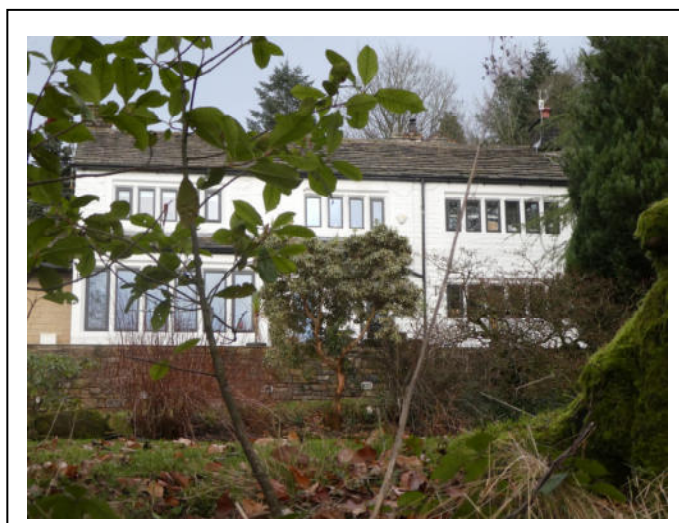
| Photo | 2020 |

18th Century farmhouse of five bays. Originally probably 2 or more dwellings. Left hand Bay 1: 20C 6 light floor length window on ground floor; 5 light recessed cavetto mullioned window on first floor. Bay 2: 20C floor length window on ground floor; similar 4 light window on first floor. Bay 3: 6 light recessed cavetto mullioned windows on both ground and first floor. Bay 4: two sets of 3 light recessed cavetto mullined windows on both ground and first floor. Bay 5: 20C extension on ground floor, 5 light recessed cavetto mullined windows on first floor.
