## BUILDINGS OF HISTORICAL & ARCHITECTURAL INTEREST SADDLEWORTH LOCAL LIST RECORD

| List No. | <b>3-014</b> |
| Property Name & Address | <b>Brook Dene, 162<br/>Huddersfield Road</b> |

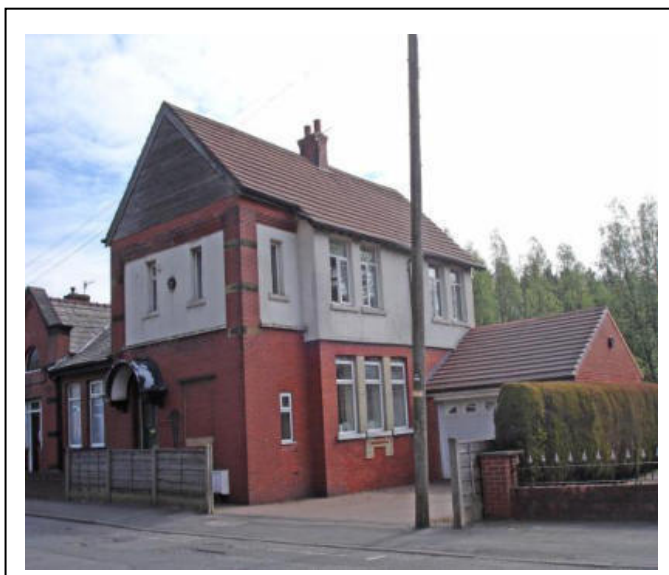
| Photo | 2011 |

House part of the once Liberal Club using combinations of stone, brick and claddings. 2 storey, 1bay, double depth. E20C. Accrington brick and rendered 1st floor. Tile roof (renewed) brick ridge stack. Front elevation: gable end with arched doorway, overlight with stained glass with semi- circular lead covered wooden hood; in-filled doorway ground floor; 1st floor proud thin string above which 2 narrow windows, 3 sandstone quoins in brick corner pedestals; courses of stepped brickwork to arch of gable which is weather-boarded. Side elevation: to left small window, remainder proud with 3 windows with sandstone mullions, ornate yellow brick pattern below and splayed brick tiled lintels; remainder obscured behind 20C garage; 1st floor small window and 2 sets of 2 windows; all decorated as front. Good repair. splayed tiles slippage.
