## BUILDINGS OF HISTORICAL & ARCHITECTURAL INTEREST SADDLEWORTH LOCAL LIST RECORD

| List No. | <b>3-020</b> |
| Property Name & Address | <b>Leeside</b> |

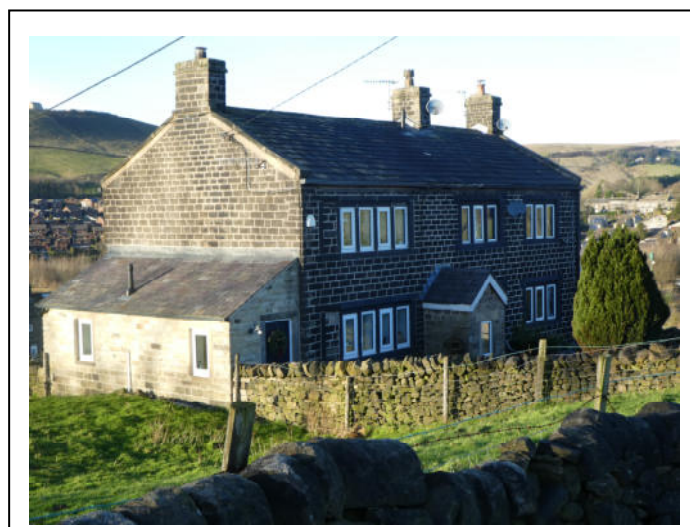
| Photo | M. Buckley 2022 |

Row of 3 workers' cottages. early 19C (post 1822). 2 storey, single bay, single depth, watershot hammer dressed sandstone. Graduated stone roof with stone gable copes and 1 ridge and 2 gable stone water tabled stacks. Front elevation: Left cottage, 5 light square faced recessed mullion windows, one blind, on each floor, centre cottage with porched doorway, 3 light square faced recessed mullion windows on each floor, right cottage with 3 light windows. Gables with single storey lean to concealing gable end doorways. Rear left cottage with 3 light windows on 2 floors, middle cottage with 3 light 1st floor and single ground floor and right cottage with single late 1st floor and 2 light widows ground floor. Good repair
