## BUILDINGS OF HISTORICAL & ARCHITECTURAL INTEREST SADDLEWORTH LOCAL LIST RECORD

| List No. | <b>3-027</b> |
| Property Name & Address | <b>Diggle Bridge</b> |

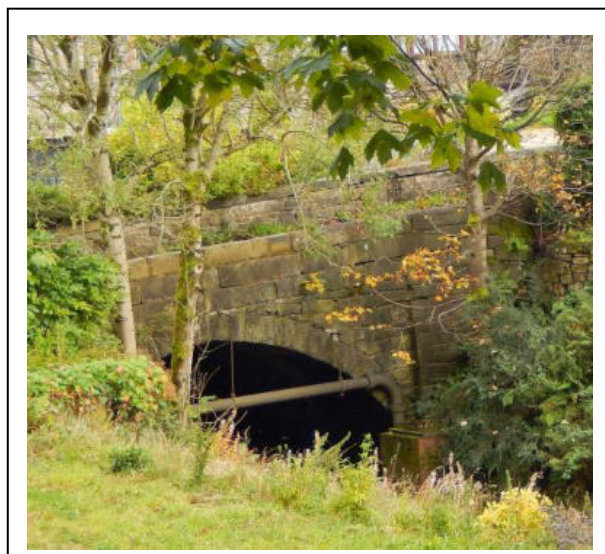
| Photo | 2011 |

Parapet topped with large squared stones with keyed arch. From medieval times the route from Standedge to Saddleworth Church & Mottram in Longdendale would have crossed here. At Quarter Sessions 1774 Bridge declared very narrow, ruinous & in decay. Saddleworth awarded £39 towards rebuilding. B. Barnes, *Passage Through Time*, SHS, 1981, p 87.

A short distance downstream Diggle Brook enters a long tunnel created by the canal, three railway lines and shunting sidings. The original canal route ran near the tunnel entrance where there is still evidence of the overflow above the brook tunnel entrance. Water from Diggle Reservoir tunnel through Greenbank emerges behind trees to right of photo. Across the goods yard access road part of old canal extant & still flowing.
