## BUILDINGS OF HISTORICAL & ARCHITECTURAL INTEREST SADDLEWORTH LOCAL LIST RECORD

| List No. | <b>4-006</b> |
| Property Name & Address | <b>2 Harrop Green Lane</b> |

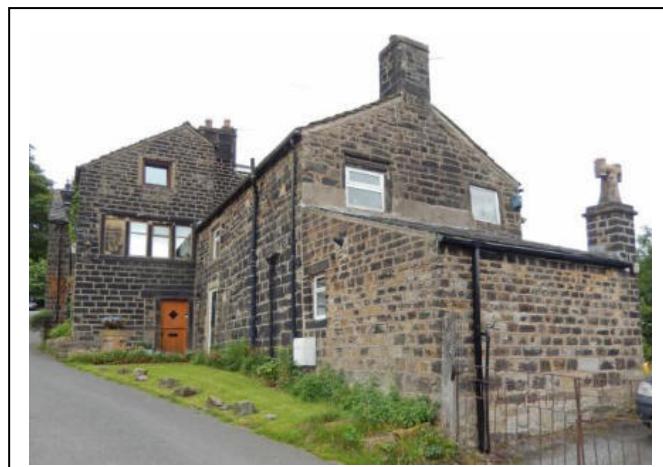
| Photo | 2020 |

EC19 possible former barn. To rear on roadside large stones with 1 original recessed window, 1 inserted doorway. First floor roof raised with rubble stone with inserted window, gable end 1 recessed window with mullion removed & 1 not recessed. Stone ridge chimney stack. Ground floor outshut. Additional building added to other end 2-storey house. Roadside with ground floor enlarged window with 1 mullion remaining. First floor 4-light square flat faced recessed mullion window. Gable part joined to first building Ground floor low level doorway to right part infilled wide door with keyed split square uprights and long lintel past filled with modern split-level door. First floor 4 square flat faced mullion windows one blind. Second floor square flat faced window mullion removed. This building was used for stabling for Diggle Co-operative Coop horses hidden by modern new build attached to west gable. Good repair

Later additional building was used for stabling for Diggle Co-operative horses, hidden by modern new build attached to west gable.
