## BUILDINGS OF HISTORICAL & ARCHITECTURAL INTEREST SADDLEWORTH LOCAL LIST RECORD

| List No. | <b>4-010</b> |
| Property Name & Address | <b>13 &amp; Oak Dean Farm,<br/>Harrop Green</b> |

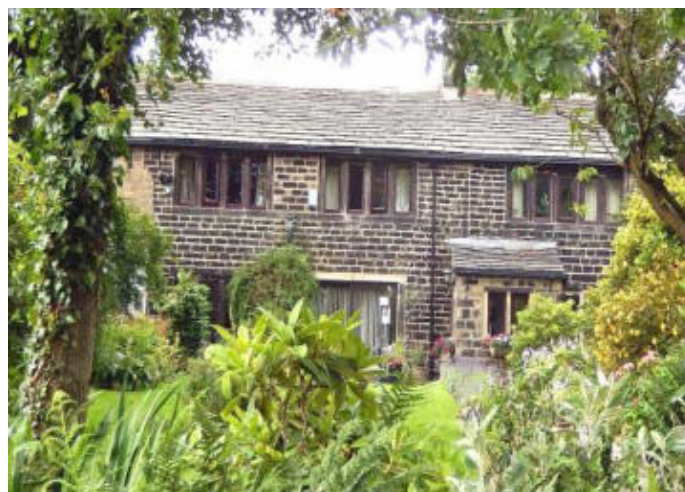
| Photo | 2020 |

EC19 farmhouse with extensions. Graduated stone slate roof with 4 chimney stacks 2 at gable ends watertabled, one cement covered. Metal gutter with iron supports. Right gable 1st floor 2x2 flat faced windows with mullions removed, ground floor hidden by trees. From right double depth single bay, 1st floor 5 flat faced recessed mullion window, ground floor added porch with 2 flat faced mullion windows. Left 2 double depth, 2 bays with vertical join. Ground floor replaced windows to floor level with stone flat faced surround. 1st floor 4 flat faced mullion windows 2 infilled with a further 5 mullion windows. Left No. 13, cleaned stone with join and keyed at top. Two replaced top opening windows ground floor white porch & bay window. No access to the rear. Good repair  
See also: Harrop, Ridge, Cote & Green in C17/18, *SHS Bulletin*, Vol. 21, No. 2.

Nos 15& 17 adjoined. To left of picture 2x windows of No.11 to illustrate the compact nature of the settlement.
