## BUILDINGS OF HISTORICAL & ARCHITECTURAL INTEREST SADDLEWORTH LOCAL LIST RECORD

| List No. | <b>4-016</b> |
| Property Name & Address | <b>1 Diglee</b> |

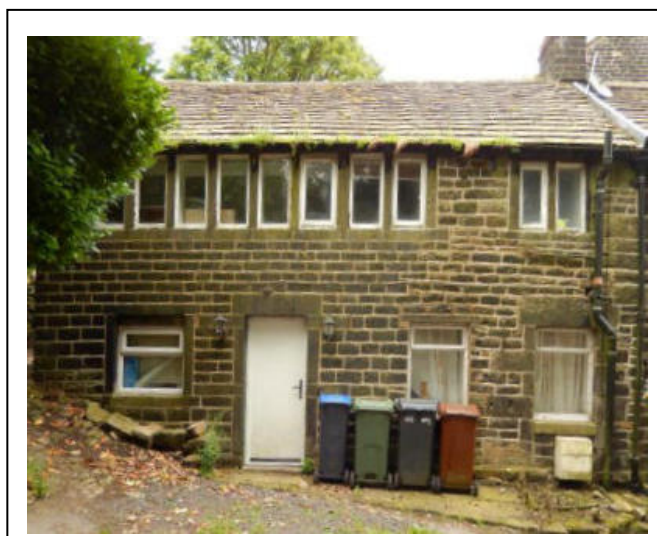
| Photo | 2020 |

House C18. Double depth, 2 bays. Groundfloor right door with large lintel & quoin surround infilled with widow top & stone below. Left modern window with lintel square faces lintel & jambs, left square surround for replaced 2-light modern window. First floor from right 2-light mullion window with square surround, possible infill, then 8-light square-faced mullion window. Corbels. Graduated stone slate roof with ridge stack to right. Roof & front wall indicate adjoining different build. Rear from right ground floor partial hidden, change in wall construction & 2-light square-faced mullion window with infilled doorway. First floor from right 4-light square surround mullion window tight against eaves, left 3-light mullion window with mid height 2-light mullion window. Change of wall structure for adjoining building. Good repair
