## BUILDINGS OF HISTORICAL & ARCHITECTURAL INTEREST SADDLEWORTH LOCAL LIST RECORD

| List No. | <b>4-032</b> |
| Property Name & Address | <b>Diggle House Farm,<br/>Dickens Lane</b> |

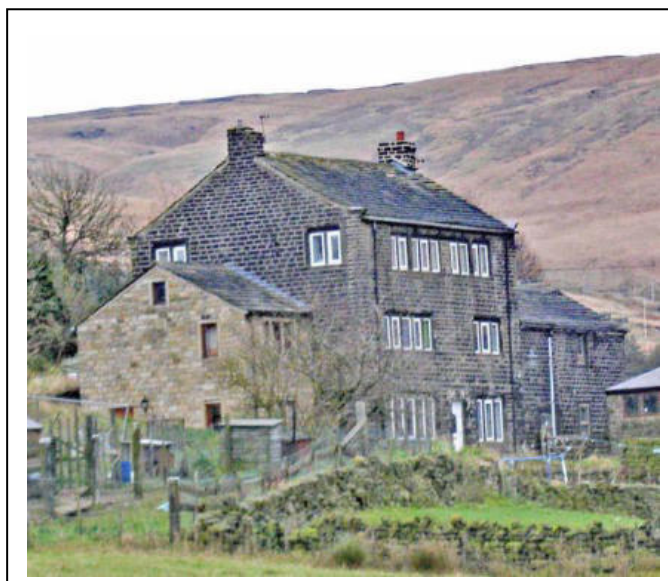
| Photo | 2011 |

Farmhouse with adjoining barn and out houses. 3 storey front, 2-storey rear, 2-bay, double depth. Built c. 1820-1850. Watershot sandstone. Graduated stone roof with kneelers but no gable cope stones; 2-gable stacks. Front elevation: corner quoins ground floor to right only; central dressed stone surround; ground and 1st storey square faced recessed mullion windows 3-lights to right and 5 to left; 2nd storey 10-lights with one infilled. Left gable end: 2 storey 20C extension; 2x2 light mullion window at 2nd- storey. Right gable: 2x2 mullion windows top storey with one at 1st floor; later adjoining barn set back; 2-storey front and 1-storey rear, front elevation with taking in door and ground floor door also glass filled old barn door way with chamfered lintel; steps to rear rising above barn roof to 20C porch at 2nd floor level. Rear elevation: 1st floor central in-filled door possibly part of 11 light mullion window, 2nd floor 2x4- light mullion windows. Reasonable repair

Solar panels now added to roof very much detract from the appearance of the property and its setting in the landscape.
