## BUILDINGS OF HISTORICAL & ARCHITECTURAL INTEREST SADDLEWORTH LOCAL LIST RECORD

| List No. | <b>4-034</b> |
| Property Name & Address | <b>1, 2, 3 Harrop Court</b> |

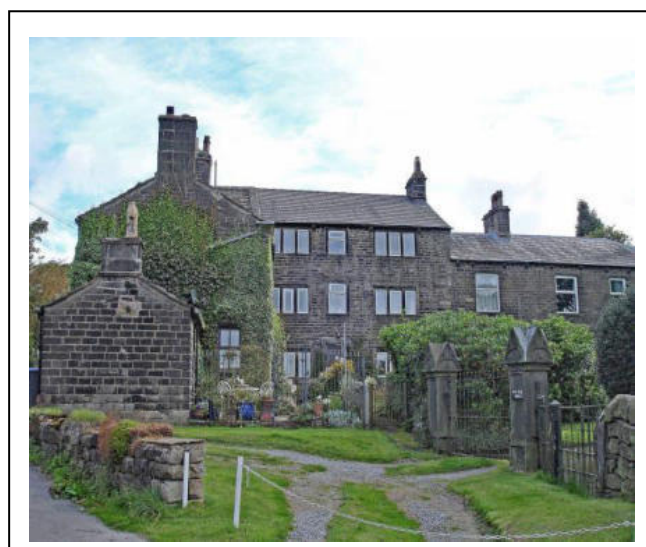
No. 1: 3 storey building: E/M19C; 1 bay, single depth, 2nd and 3rd storey hidden by No. 2 at a right angle. Hammer dressed watershot sandstone with graduated stone roof. No indication of separate construction; front elevation 1x 2nd floor window above the attached building; gable end on roadside; ground floor, extreme left dressed stone doorway, large vertical stone slab to left of door as protection from stable door, 1 large window with flush lintel and proud sill, 1st floor 2 large windows with large lintel and proud sill, 2nd floor 5 light square face mullion window, both sets of windows probably not original.

No. 2. Road side., E19C separate construction with later alterations, graduated stone roof, gable ashlar block stack, rear; 1 in filled doorway, 1 square cut insert stone 1st floor window, 1 large 2-floor stair window with evidence of insertion, extended single storey keyed by 3 separate stones, with 1 doorway and later window insert, graduated stone roof, ashlar stone stack. Front elevation; 2 storey, 2 bays, single depth, roof with stone cornice; central doorway with window either side, 1st floor 3 large windows with square cut surround, corbels gutter brackets Good repair

No. 3. Front elevation right 2 bays: ground floor dressed stone surround doorway, either side 3 light recessed square faced mullion window, stone flush lintel and sill; 1st floor either side 3 light recessed square faced mullion windows, stone flush lintel and sill, with central slightly taller and wider inserted window; 2nd floor the same Rear: ground floor left 3 light mullion window, to right window below proud lintel, (possible step outside 2 taking in doors, now windows); second floor 8 light square faced mullion window. Left hidden bay.

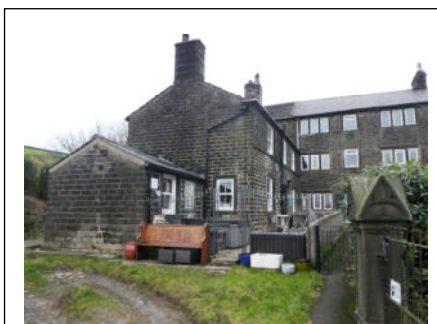
**No 1, L; No. 2 C and R.**
