## BUILDINGS OF HISTORICAL & ARCHITECTURAL INTEREST SADDLEWORTH LOCAL LIST RECORD

| List No. | <b>4-047</b> |
| Property Name & Address | <b>Brun Clough House</b> |

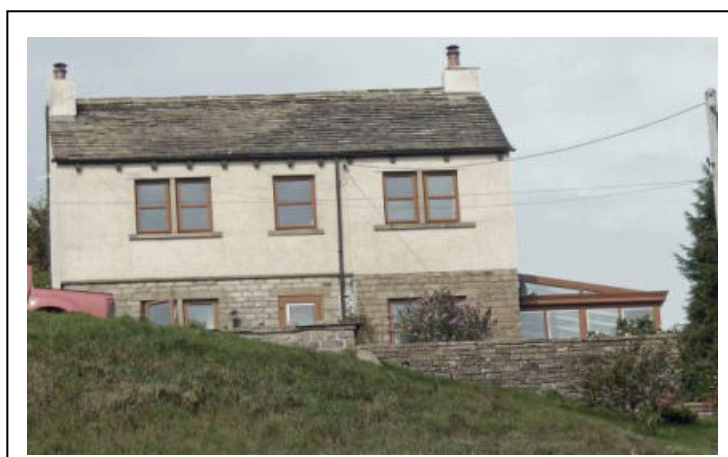
| Photo | 2020 |

LC 18, EC19 double bay single depth with 1 bay extension, modernised. Sandstone ground floor, rendered first floor. Ground floor replaced 4-light mullion windows with 2-light king mullion window, 2 light mullion window replaced with square faced lintels & proud sills. Single window same. Extension to right double window same with gable modern sun lounge. First floor widows as ground floor. Corbels for gutter support graduated stone slate roof with 2 ridge stacks either end. Good repair
